Repairing Toyota 2AZ-FE engine head bolt threads

Mark Mitchell

September 2017

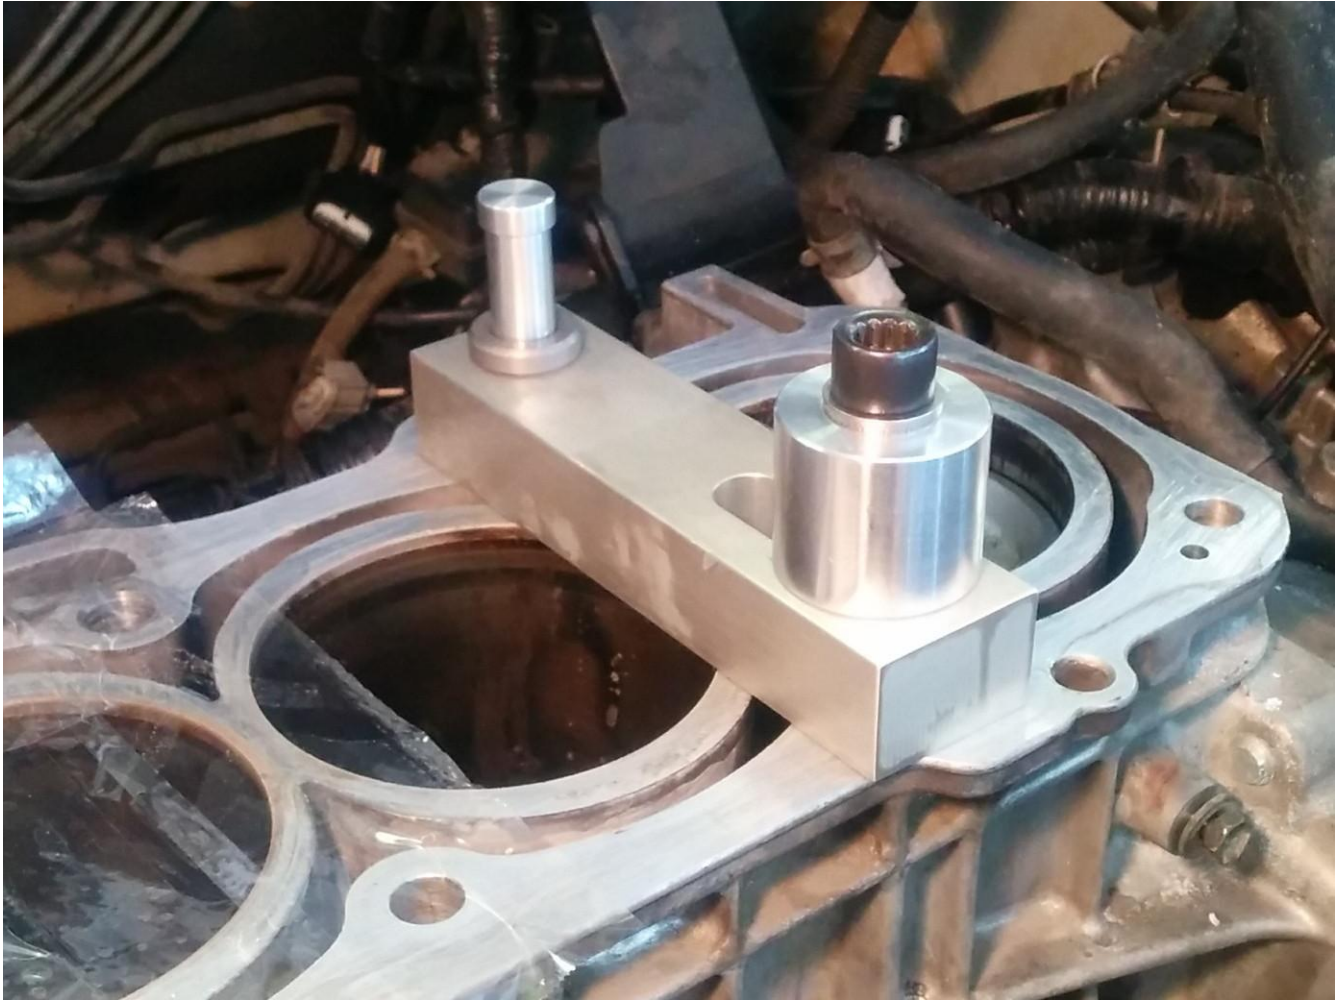
Figure 14: Jig block attached to head

Attach the jig block to the bare block surface, rather than on top of packaging tape. Then put tape over the adjacent areas, running up the side of the jig block a bit.

Use one of your new head bolts to attach the jig block, since the old bolts may have stretched threads.

After firmly bolting the jig block to the cylinder block, before you start drilling, make a visual inspection that it is in fact aligned properly with the hole.

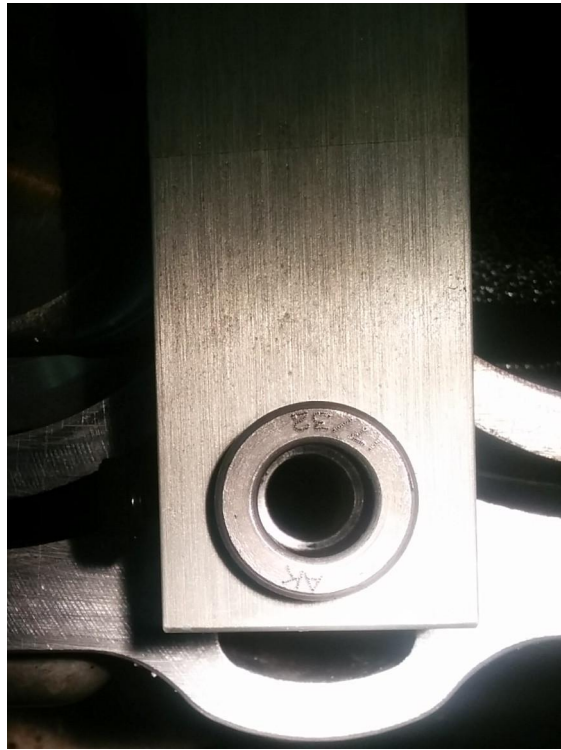
Figure 15: Jig block visual check before drilling

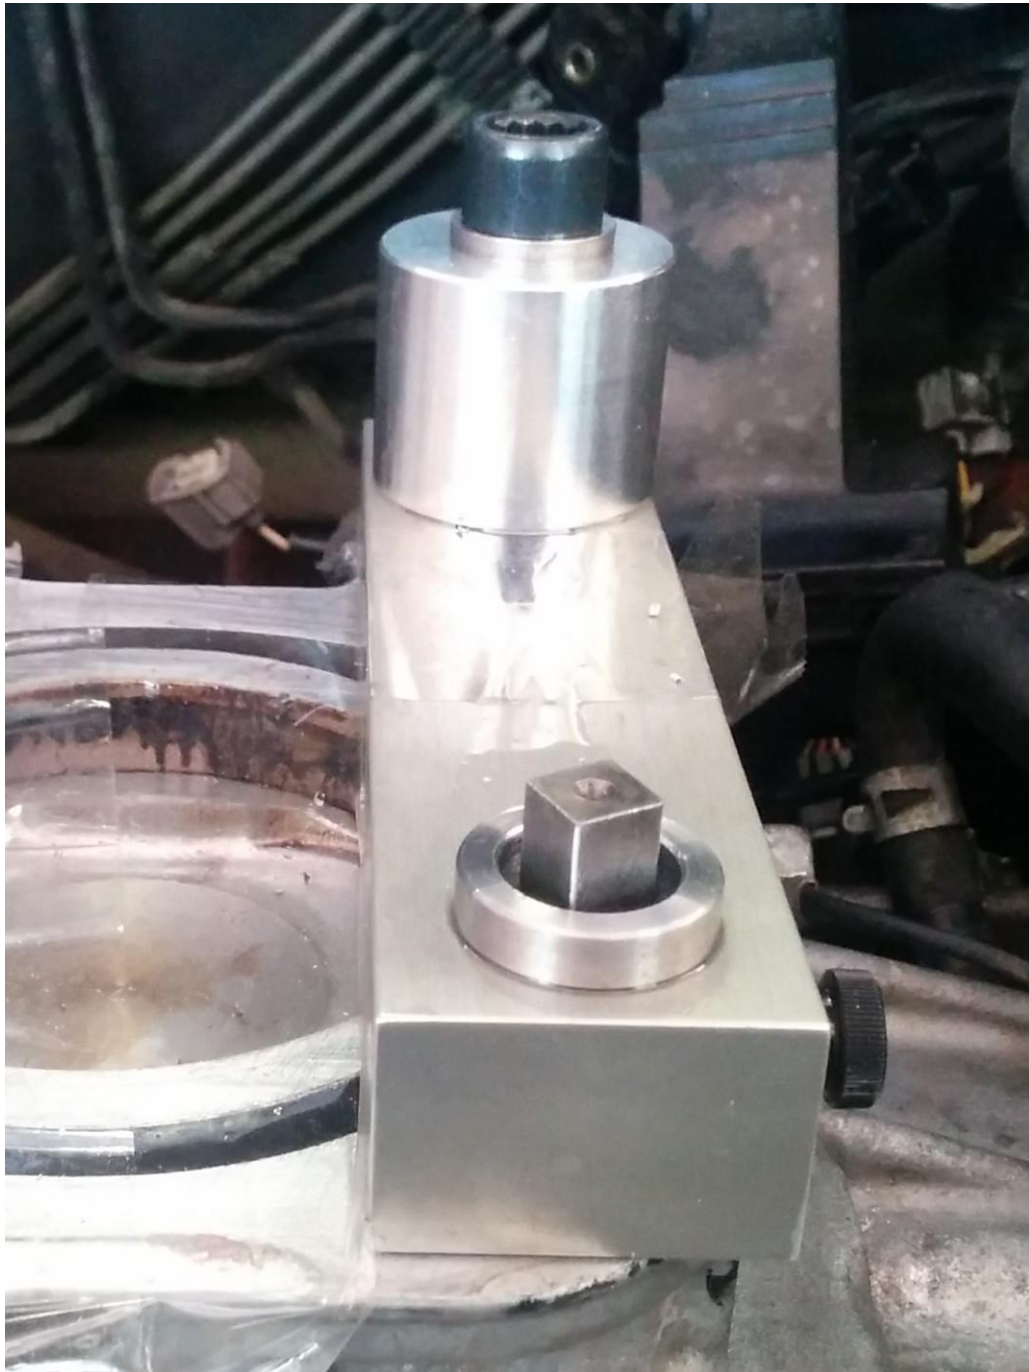
Figure 18: This is as far as you can go with jig block in place

Tap as far as you can go with the jig block in place.

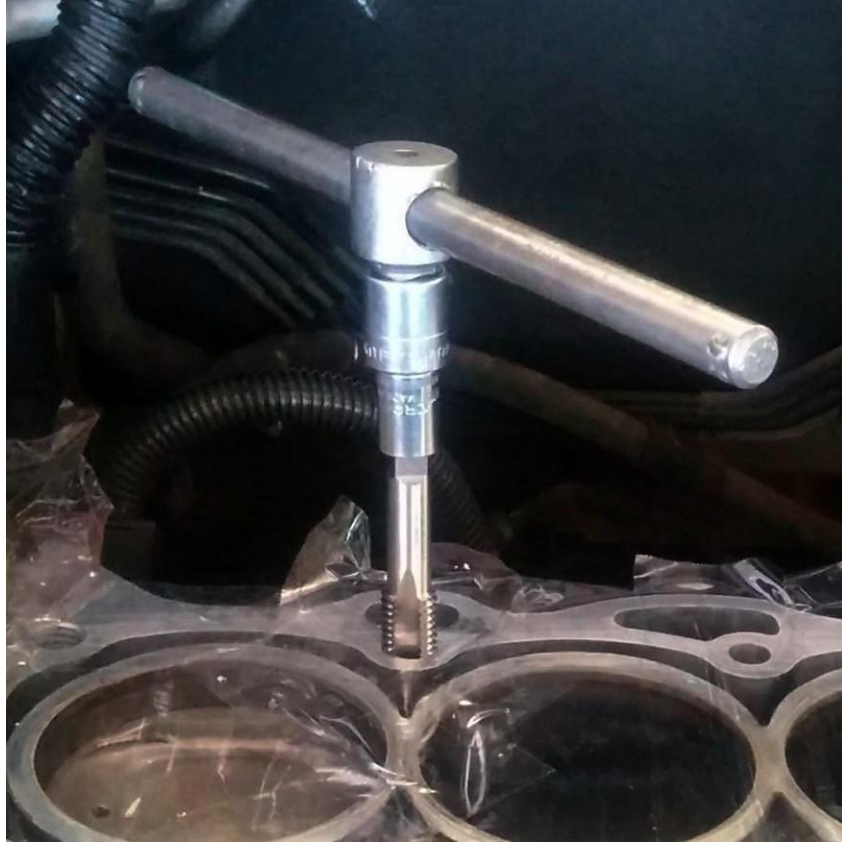
Figure 19: Remove the jig block and tap the rest of the way

Then remove the jig block to tap the rest of the way.

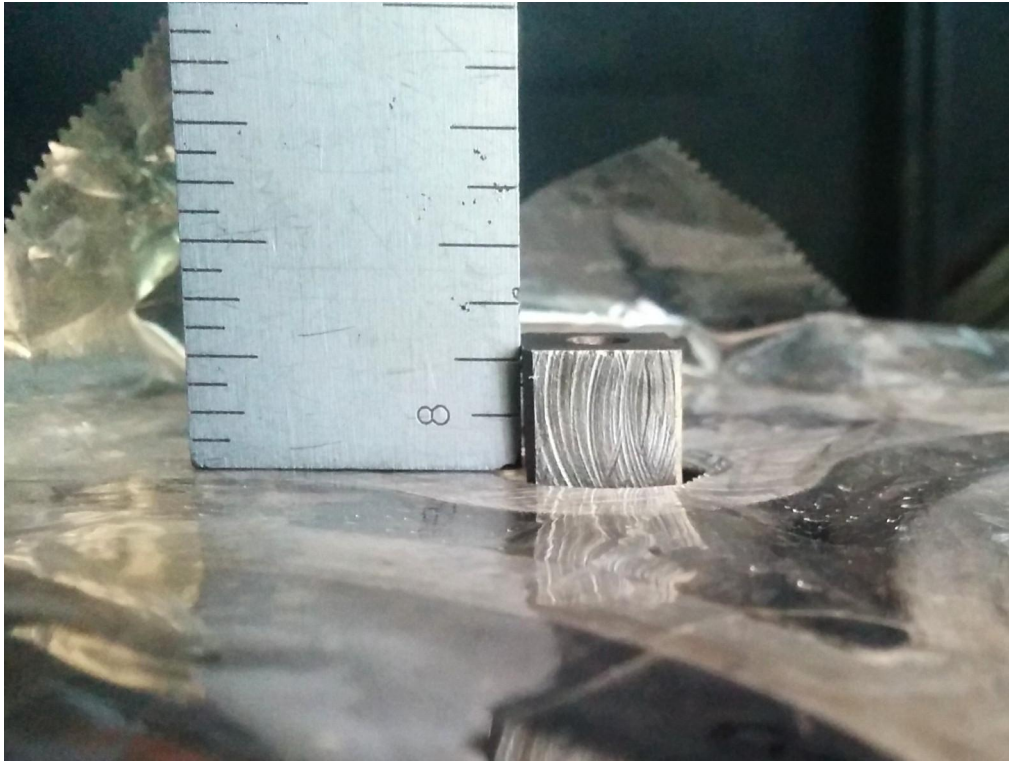
Figure 21: After tapping to a depth of 3 1/4", only about 1/4" of tap remains above the cylinder block surface

The instructions say that the top of the insert should be 1 1/2" from the top of the engine block on my engine (2006 and older 2AZ-FE).

The insert is 1 3/4" long, so the depth of the tapped threads must be 3 1/4", or a bit more. The tap itself is 3 13/16" long.

So, to tap the threads to a depth of 3 1/4", only about 1/4" of tap will remain above the cylinder block surface.

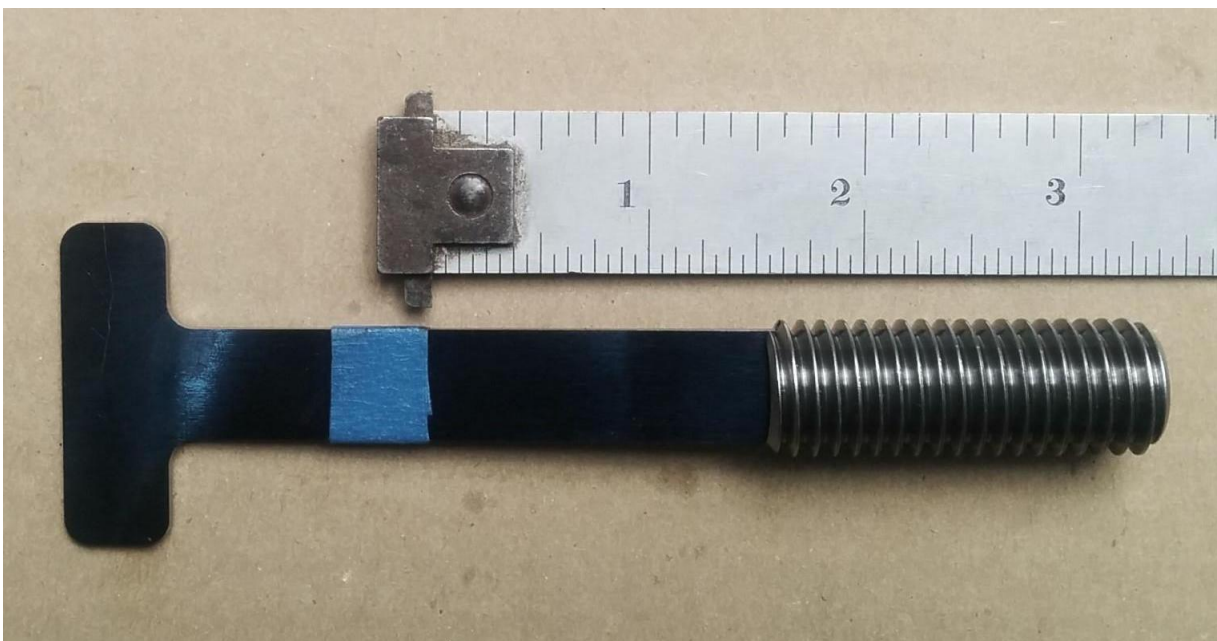
Figure 22: Insert wrench with tape to mark depth

After tapping, screw in an insert to see if the tapped threads are deep enough. I put a piece of tape on the insert wrench to indicate the depth.

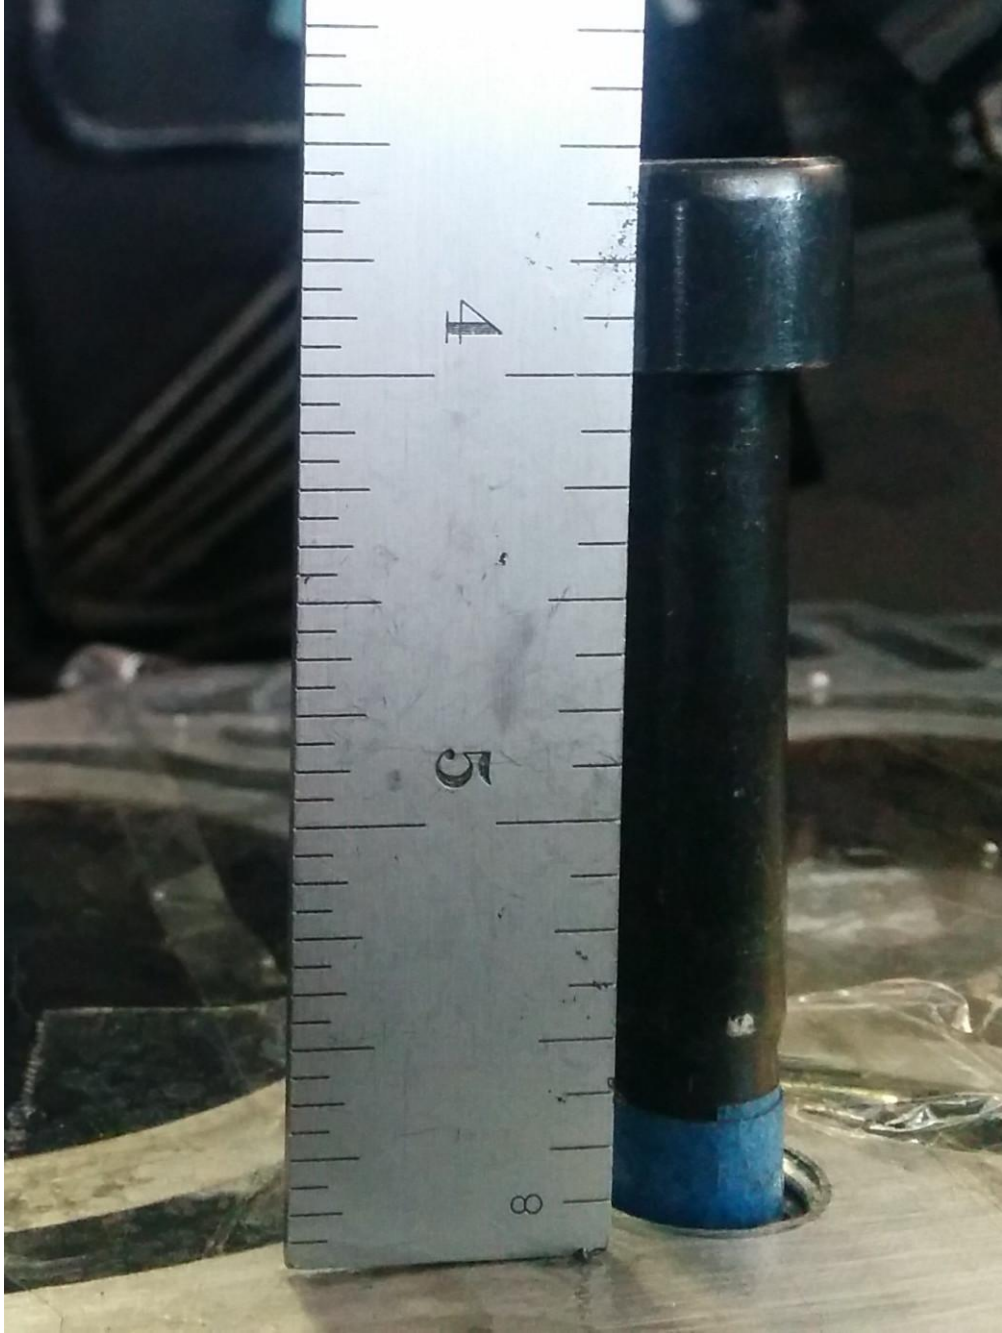
Figure 23: Check the head bolt will screw in far enough

Then screw in a new head bolt to make sure it will go in far enough. I measured the distance through the cylinder head bolt hole to be about 2 1/8". Add to that the thickness of the head bolt washers which is about 1/8". So the head bolt needs to be able to screw in far enough so the distance from the cylinder block surface and the bottom surface of the bolt head is less than 2 1/4" by a comfortable margin. Measure your own cylinder head and washers to be sure.

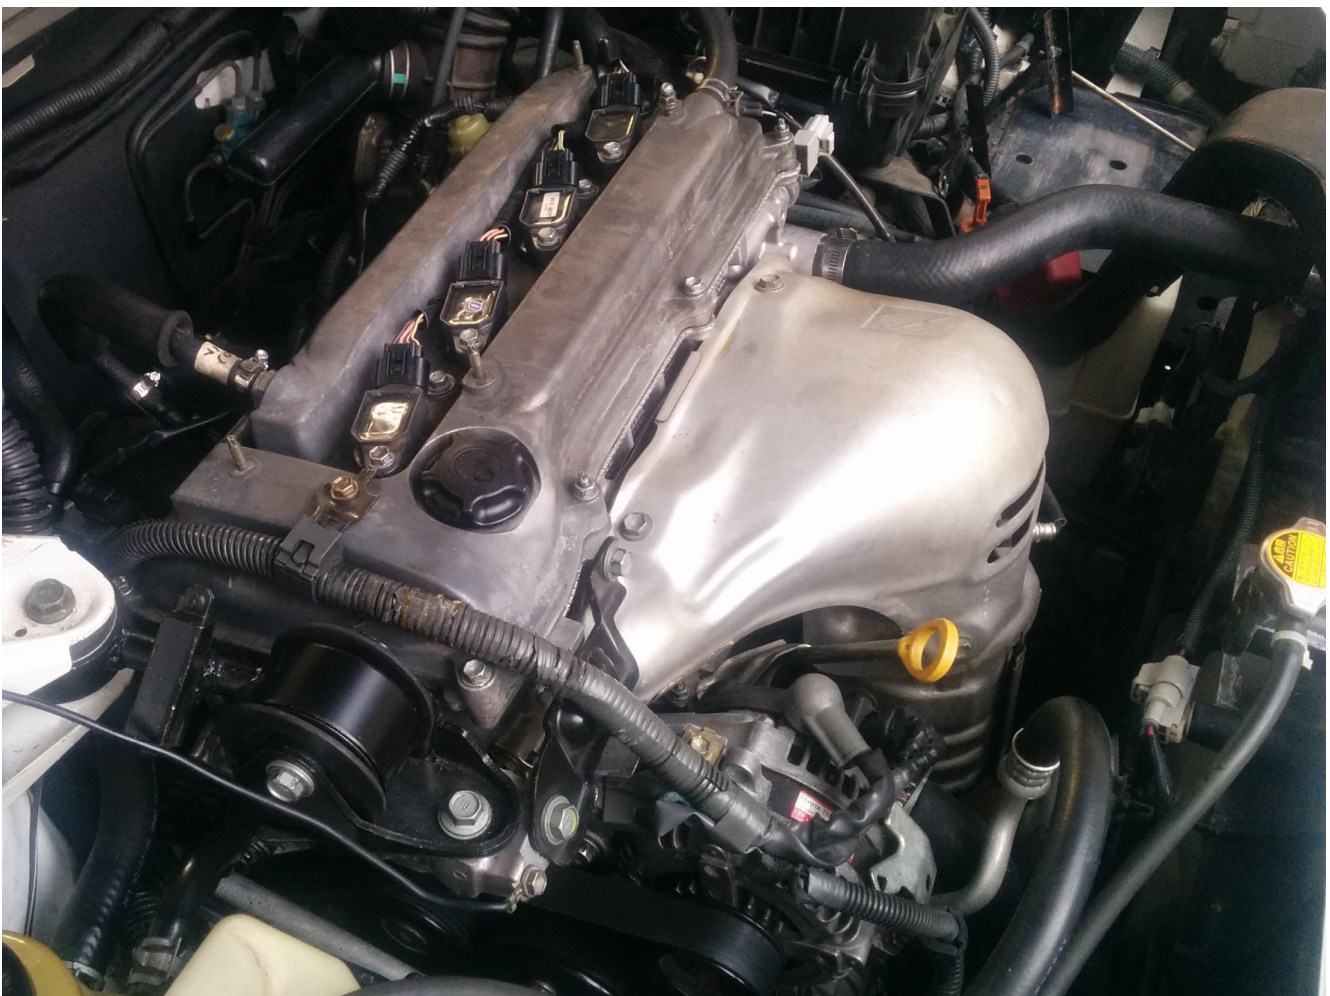
Figure 24: 2AZ-FE engine all buttoned up
