Repairing Toyota 2AZ-FE engine head bolt threads

Mark Mitchell

September 2017

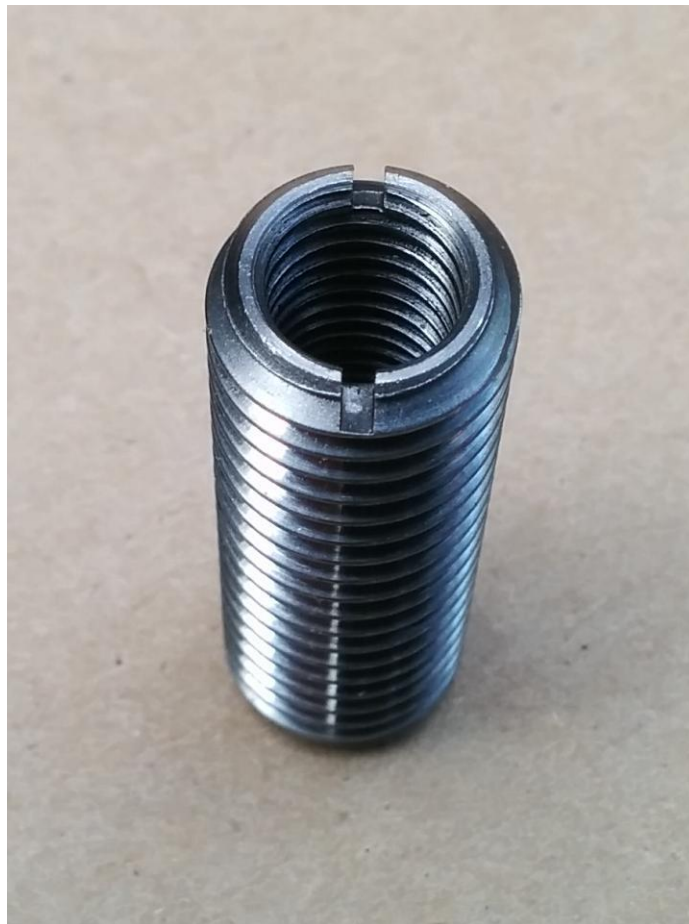
Figure 1: Steel thread insert

Eleven steel thread inserts. (One extra, the engine needs 10). The insert has M11x1.5 threads on the inside, and 5/8" x 11 threads on the outside.

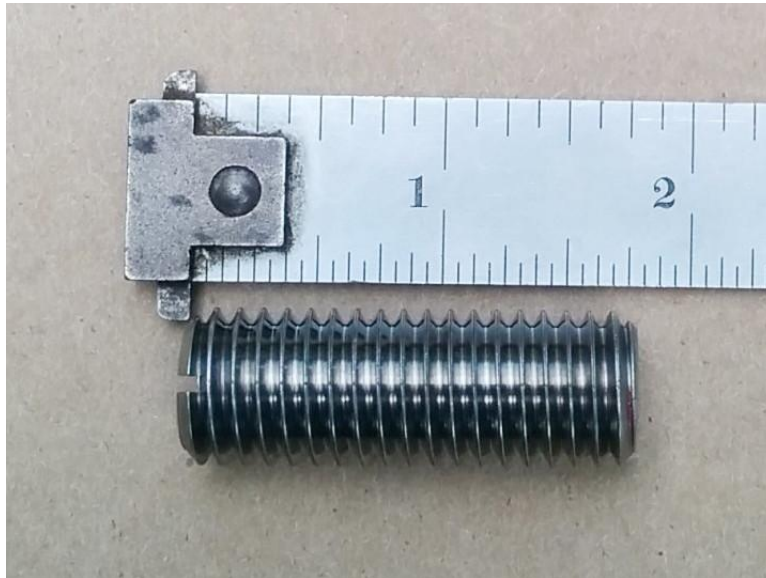
Figure 2: The steel thread insert is 1 3/4" long

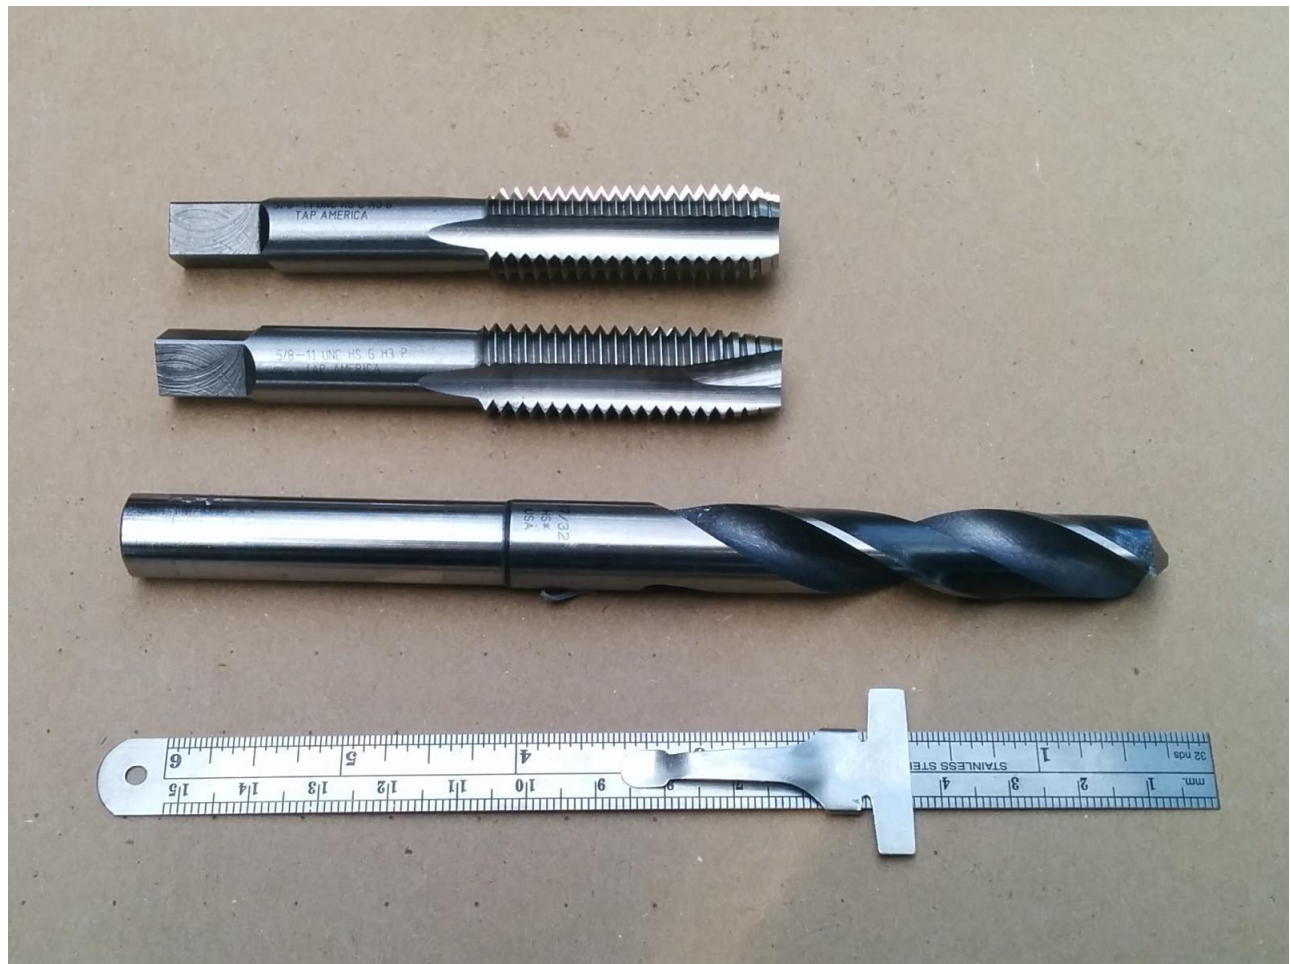
Figure 3: A 17/32" drill, and two 5/8" x 11 taps (one plug, one bottoming)

A 17/32" drill, and two 5/8" x 11 taps (one plug, one bottoming).

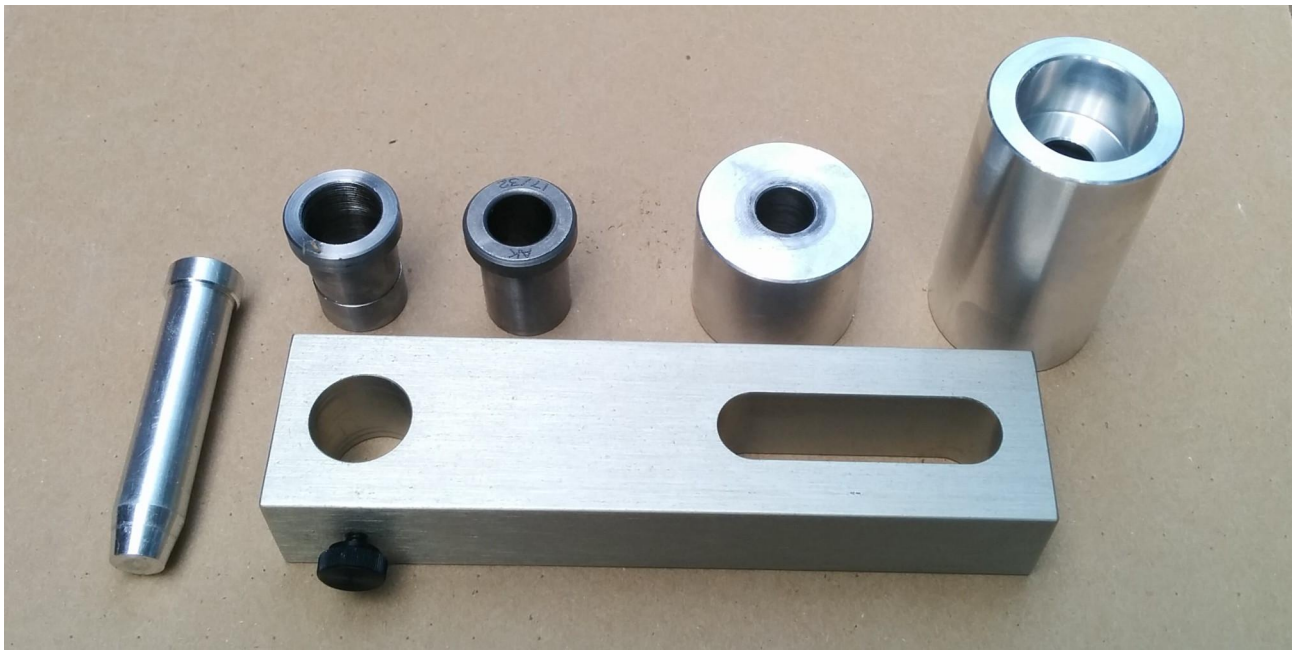
Figure 4: The alignment jig for drilling and tapping the holes.

The alignment jig for drilling and tapping the holes.

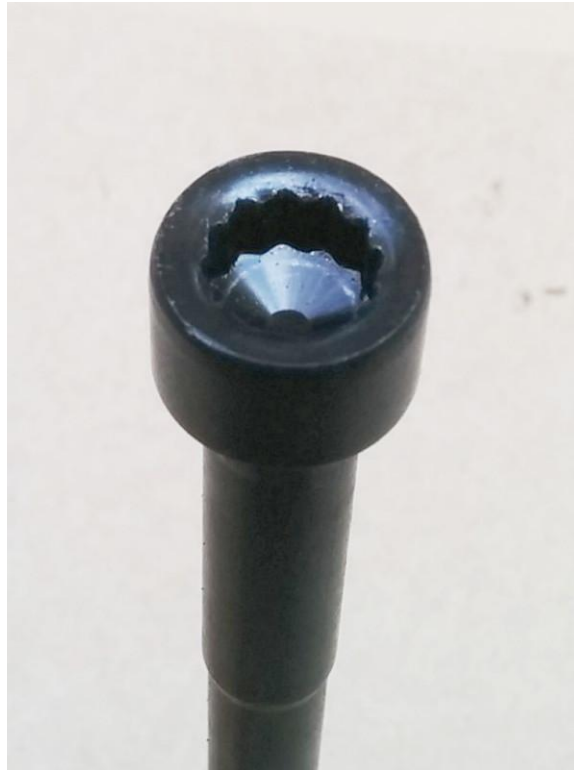
Figure 6: The head bolt head

- A set of metric sockets and ratchets and wrenches.
- A 1/2" drive torque wrench.
- A special 10mm x 12-point "Double-Hex" socket to fit the cylinder head bolts. Toyota calls it a bi-hexagon socket. It's not a socket in the literal sense, it's the inverse of a socket.

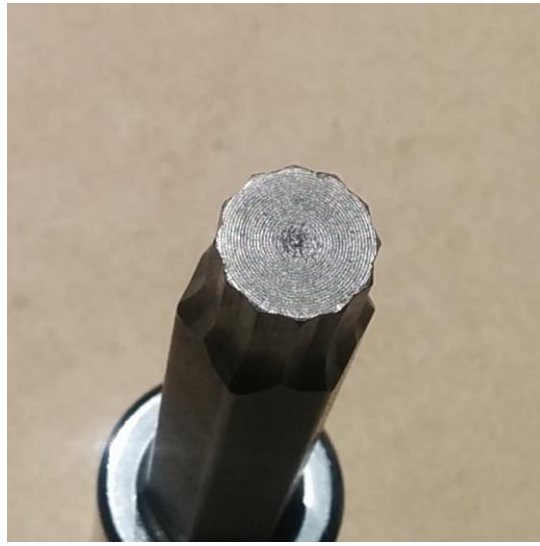
Figure 7: The correct double-hexagon socket driver

Buy the proper tool. Using the incorrect tool will risk tearing up the socket on the cylinder head bolts. Really, buy the proper tool.

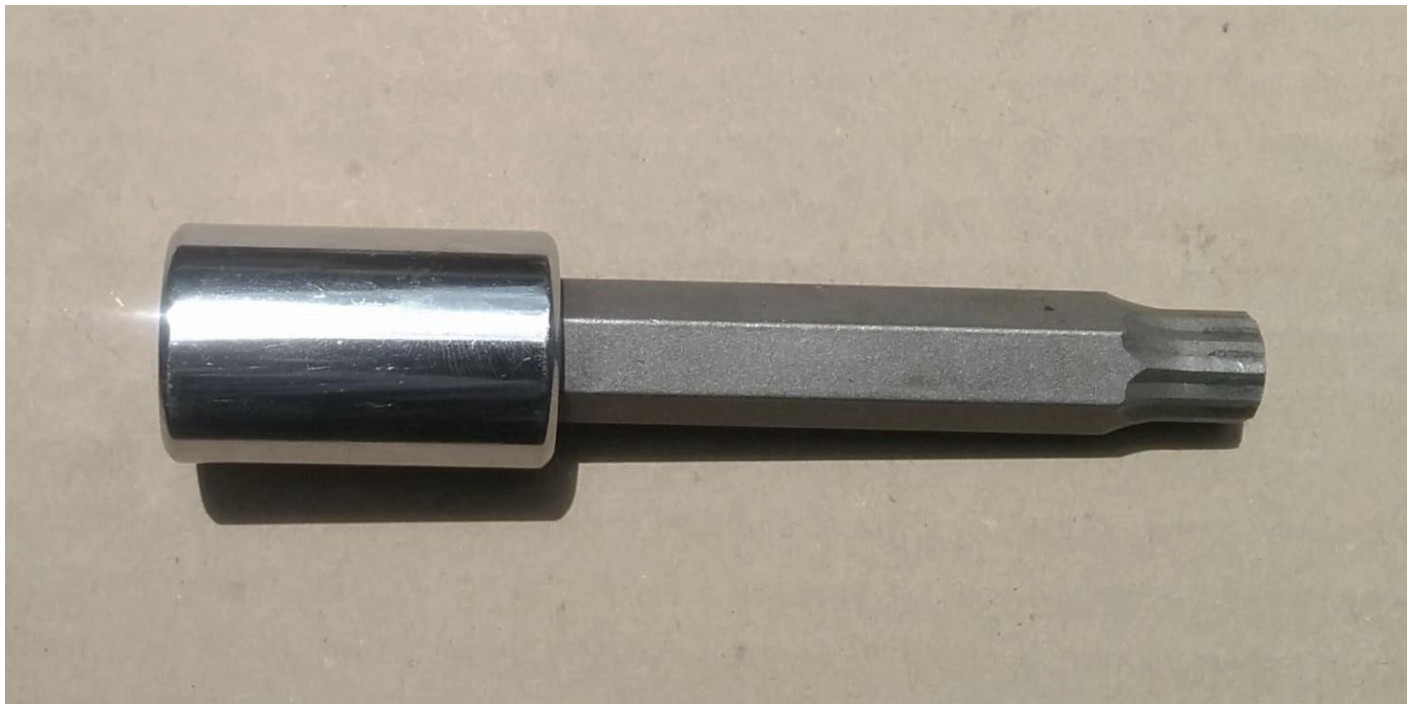
Figure 8: CTA Tools 9292 10mm Head Bolt Wrench (Toyota)

You probably won't find one on the shelf of your local auto parts store. Snap-on makes one. OTC also makes one. The one I used is the **CTA Tools 9292 10mm Head Bolt Wrench (Toyota)**. It cost about \$15.

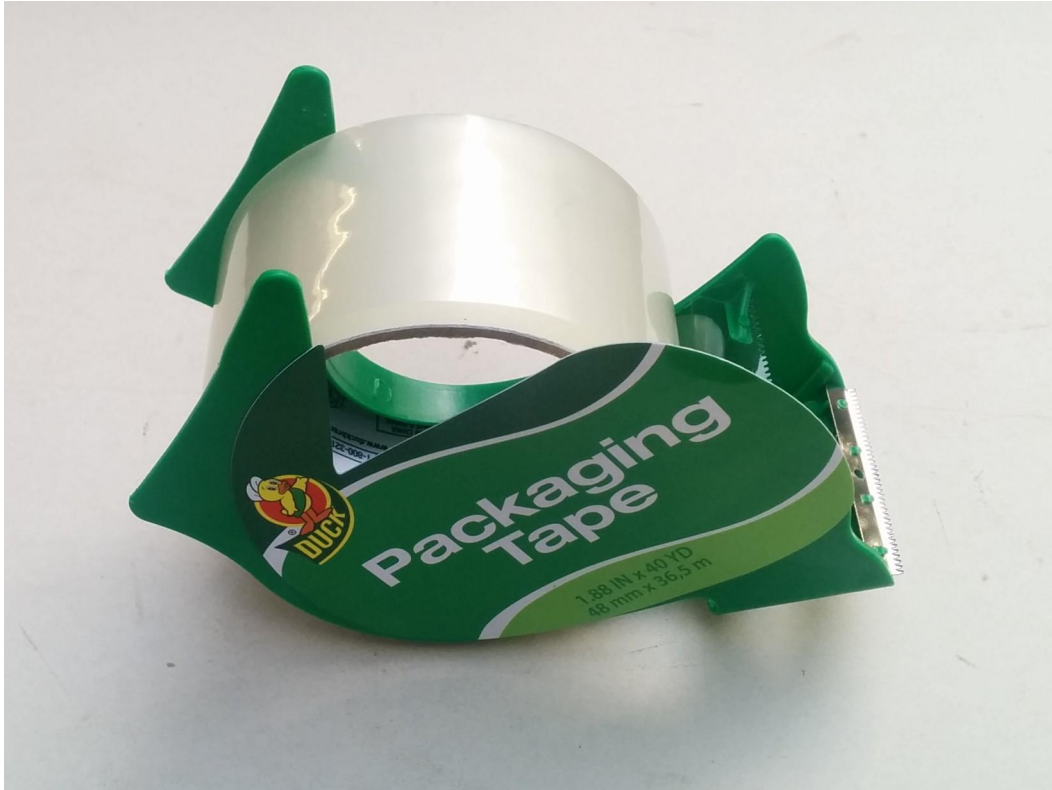
Figure 11: Packaging tape, for covering up the cylinders

Use the packaging tape to cover all the open parts of the cylinder block, to prevent aluminum chips from falling down inside the engine oil galleries and water jacket. Also cover the timing chain area.

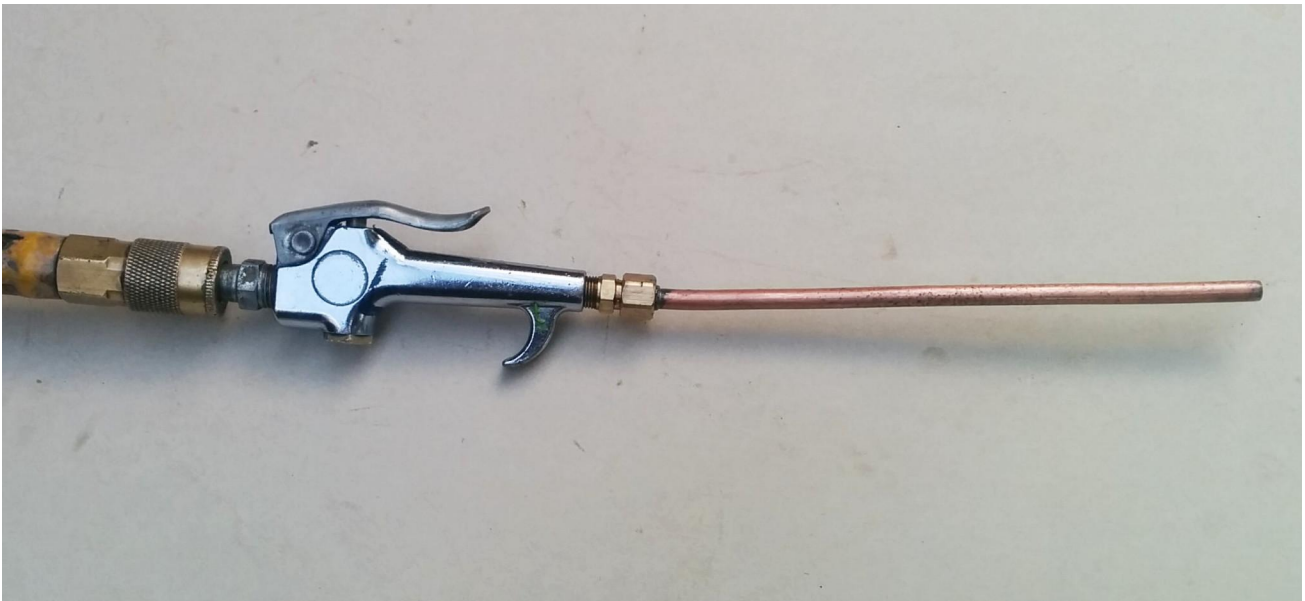
Figure 12: Compressed air wand

Place the nozzle of your shop vac close to the hole to suck up the chips as you pull the drill out. After removing the drill, use your compressed air wand in the hole to blow remaining chips out, with your shop vac still vacuuming. Place a rag around the hole as a fence to try to keep the chips from flying all over.

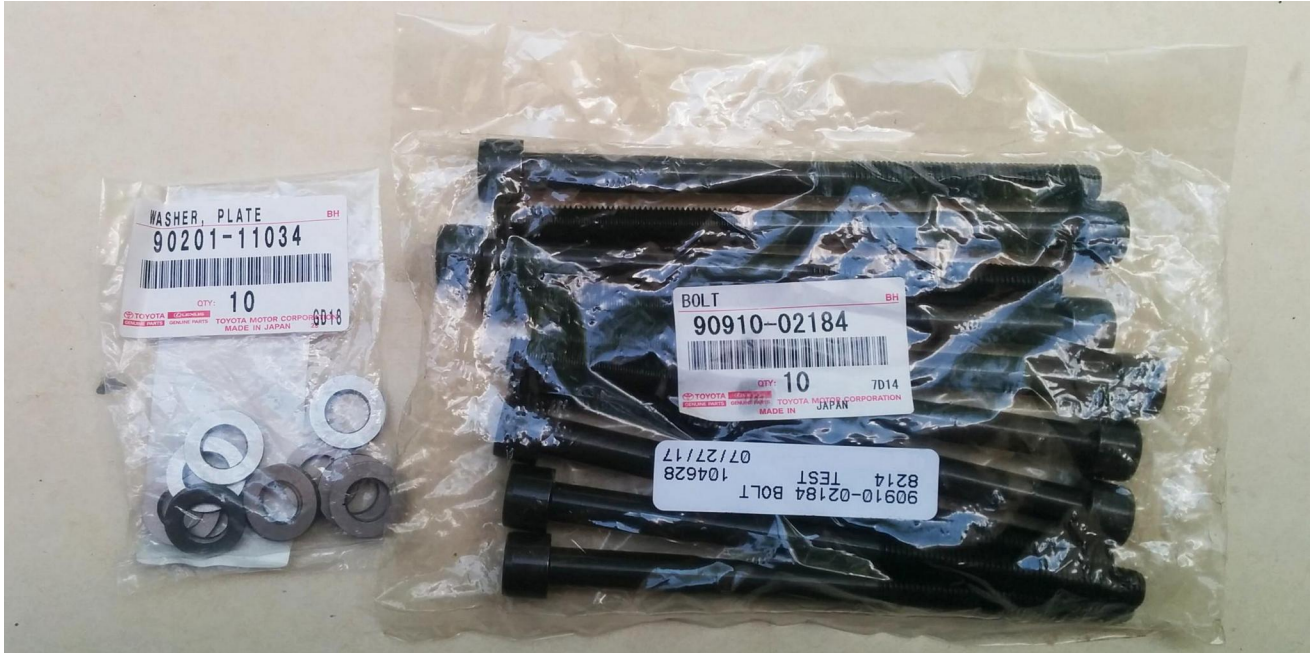
Figure 13: Toyota head bolts

- A gallon of mineral spirits, for cleaning parts and bolt holes.
- A cylinder head gasket set.
- A set of new cylinder head bolts and washers. Huhn Solutions recommends using genuine Toyota bolts, instead of Felpro or others. I can confirm this advice is sound. They cost twice as much as Felpro bolts (\$100 for ten Toyota bolts, vs. about \$50 for ten Felpro bolts), but just spend the money.

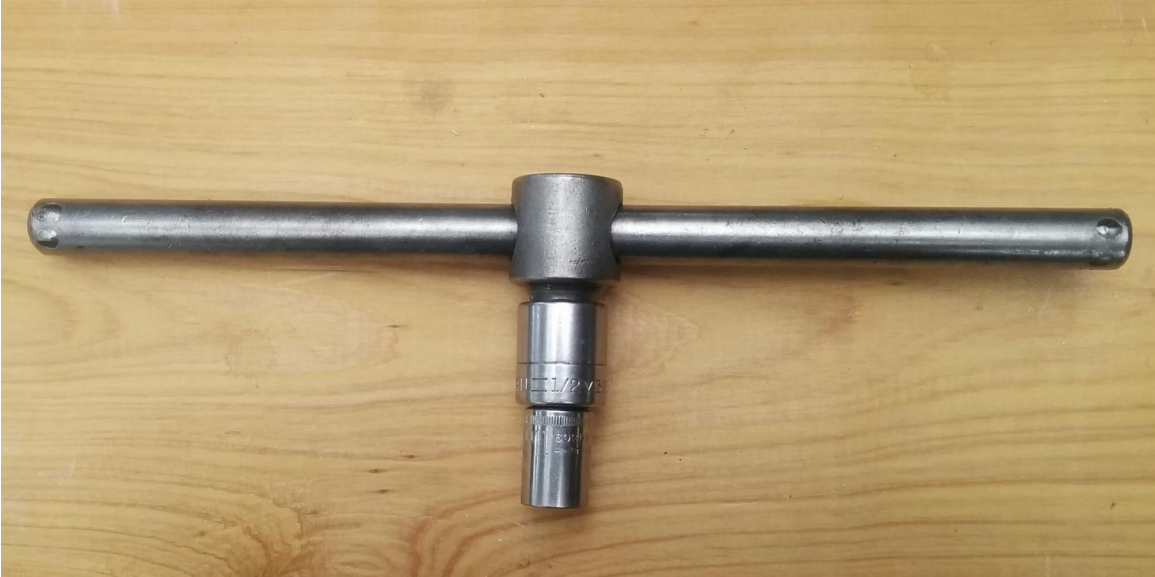
Figure 16: T-handle tap wrench

I found that my tap wrench was too long. The handles would hit against the inner fender wells or other items in the engine compartment as the tapping progressed. I had a 1/2" drive T-handle to which I attached an 11mm socket.

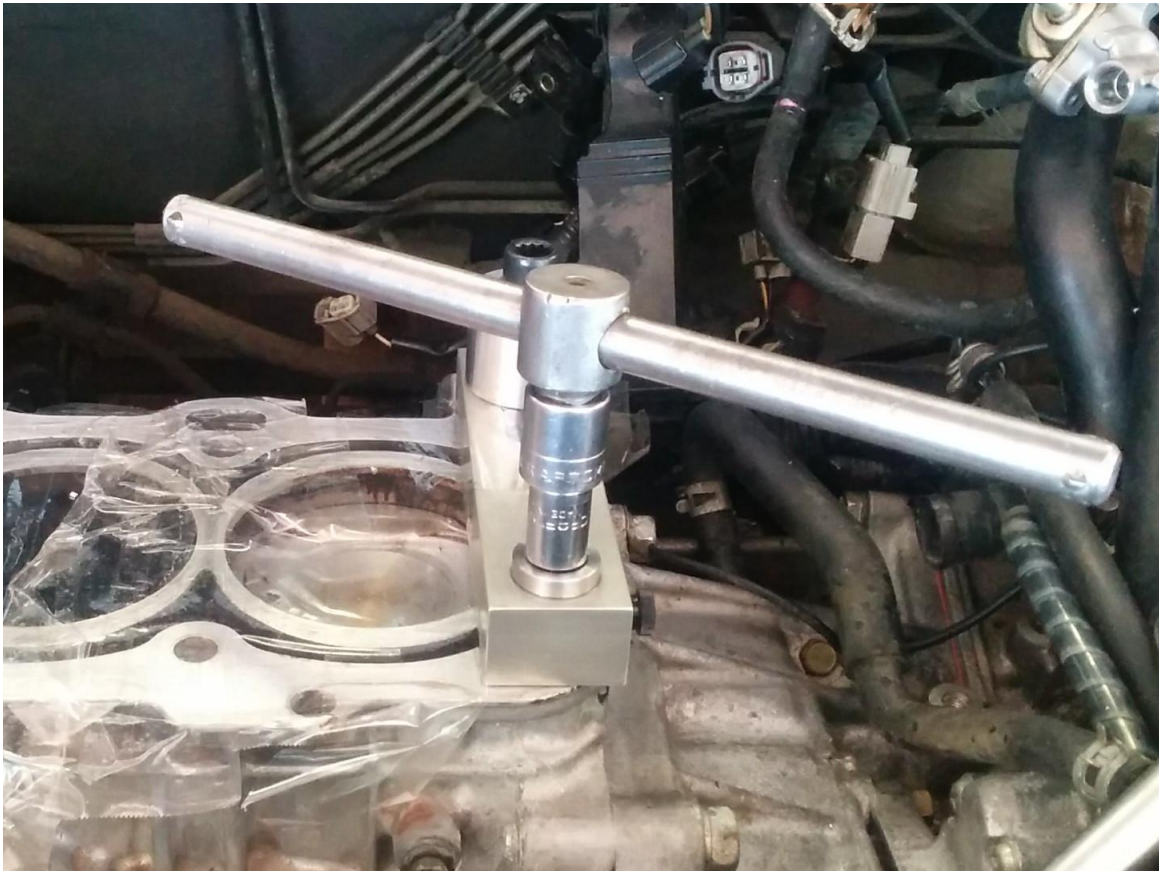
Figure 17: Tap with jig block

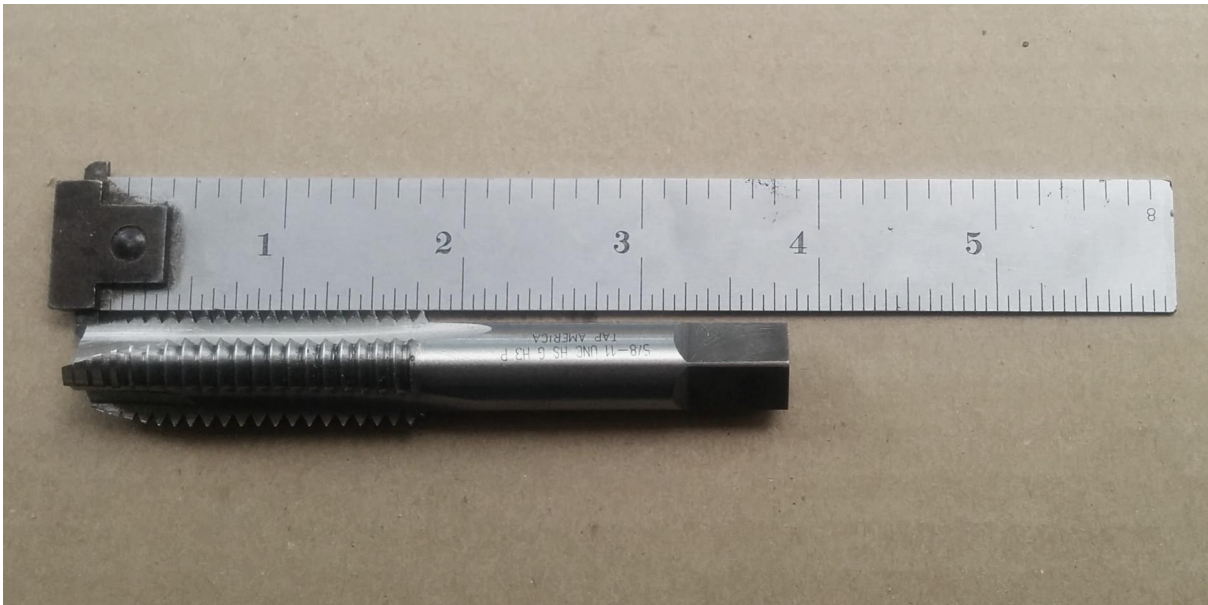
Figure 20: The tap is 3 13/16" long
